# Docking and dismantling of the former CT Pernambuco (D30)

*Also known as USS Bradley DE/FF 1041*

SOURCE: BNRJ's Portfolio Report - Issue I - 2nd Semester 2015

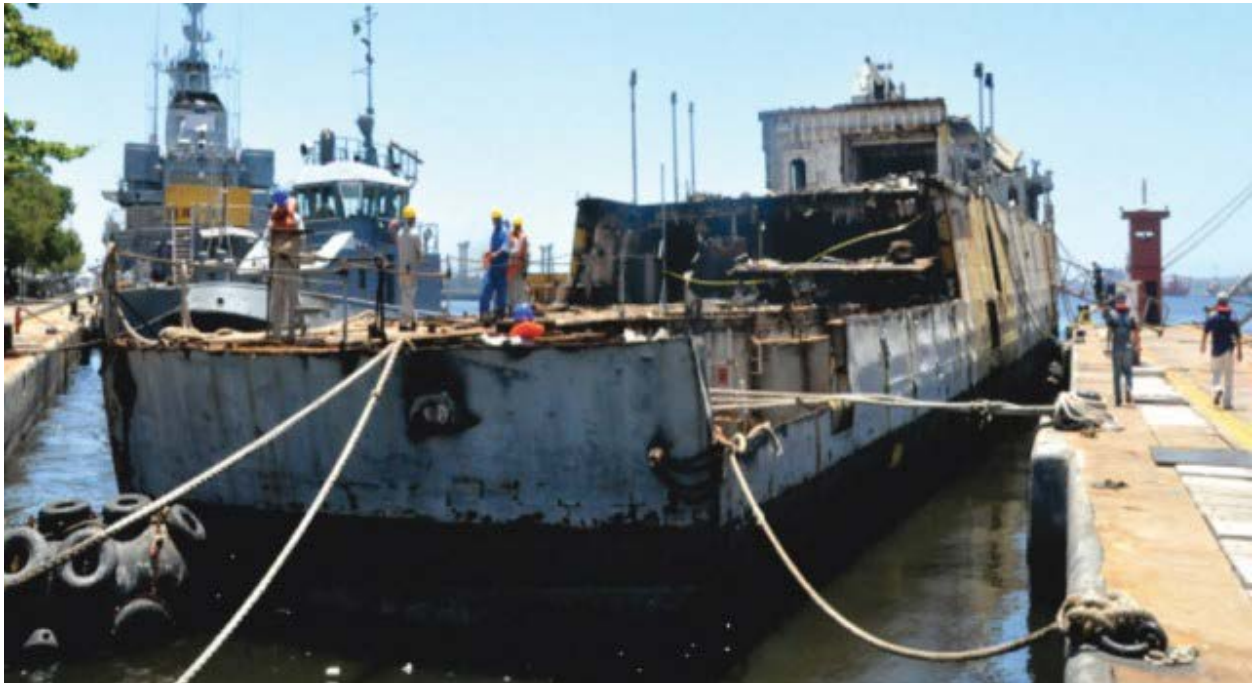
The state of structural degradation of the hull, together with the partial dismantling of the hull, with the complete removal of hulls, dies and horns of the decks (photo1), entailed enormous difficulties and risks for the execution of unmanning maneuvers and its safe trailer up to the Alte dam. White.

Picture 1 - Situation of the hull moored in Pier 3 internal, already partially undone

Thus, in order to execute the necessary towing, with the minimum of risks, BNRJ hired a specialized company - PICOLO E ASSOCIADOS LTDA. - to assess the structural condition of the hull (vessel beam) and to draw up a towing plan for the condition in which it was.

On October 14, 2014, the aforementioned company presented the aforementioned work, which, after being analyzed and ratified by DEN, pointed out the need in a series of actions, by the Industrial Department of the BNRJ, to reinforce the points of the hull which presented structural fragility and also to install devices of fortune, replacing the bollards, horns and balustrades, which were removed during the partial dismantling on the quay.

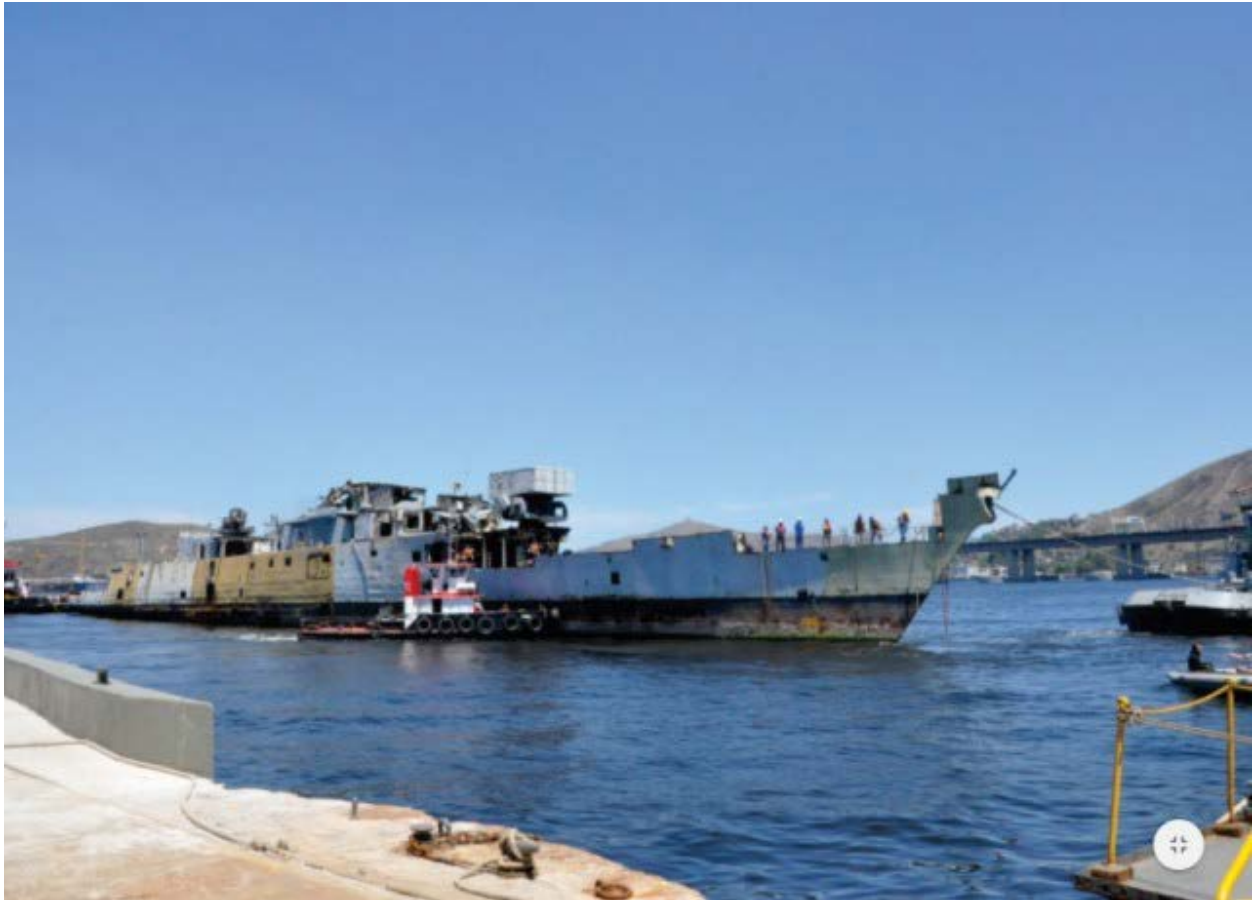
Photo 3 - Hull reaching the Alte dam. White

It was incumbent upon CASOP to place concrete coffins in the fragile locations of the Bravos plating, as well as the installation and operation of motor-pumps for eventual emergency sewage, during the hull towing of the internal Pier 3 to the dike (photos 2 and 3).

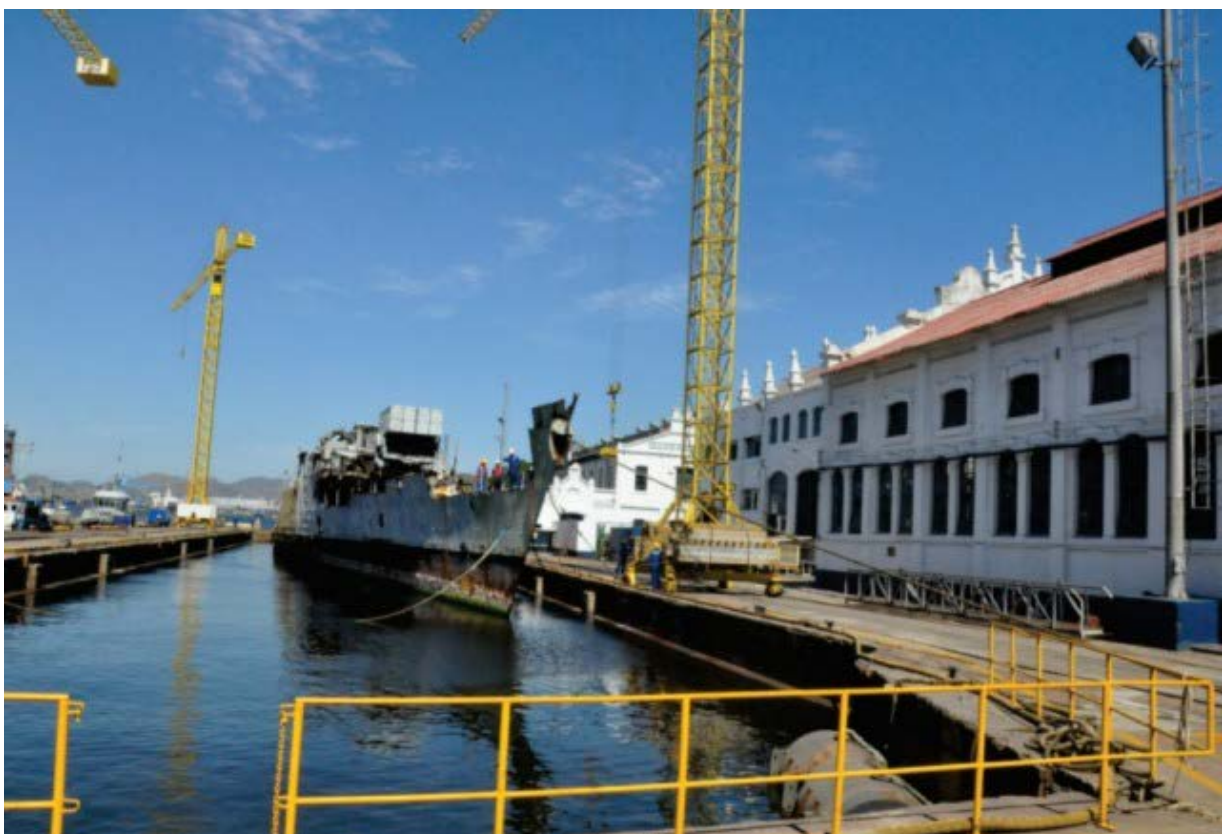
Due to the considerable navigation draft and the dimensional characteristics of the appendages of their hulls (sonar, rudder and propeller), the Pará Class was never certified in the BNRJ. Thus, to make feasible its docking would be sine qua non the reduction of its navigation draft. Consequently, the first difficulty to be overcome would be to avoid that during the passage of the hull along the dyke, its gigantic sonar dome (16 x 6 m) would not overturn the dozens of riding stables and cots to support the hull.

Photo 4 - Diagonal displacement along the dyke, with the protruding bow to the chassis of the crane

This obstacle was circumvented, literally, by the type of maneuver adopted, moving the hull along the dyke, always diagonally to the center line of the dyke, to ensure that its dome passed between the line of lateral cradles and the side wall of the dam, where the maximum clearance was 0.30m. Because of this critical play, in order to maintain the correct positioning of the dome, the device was used to strike its bow to the chassis of the crane, which accompanied it, in parallel, during its displacement to safe area for it to return to the center of the dam, without the risk of the dome overturning the cribs and stables (photo 4).

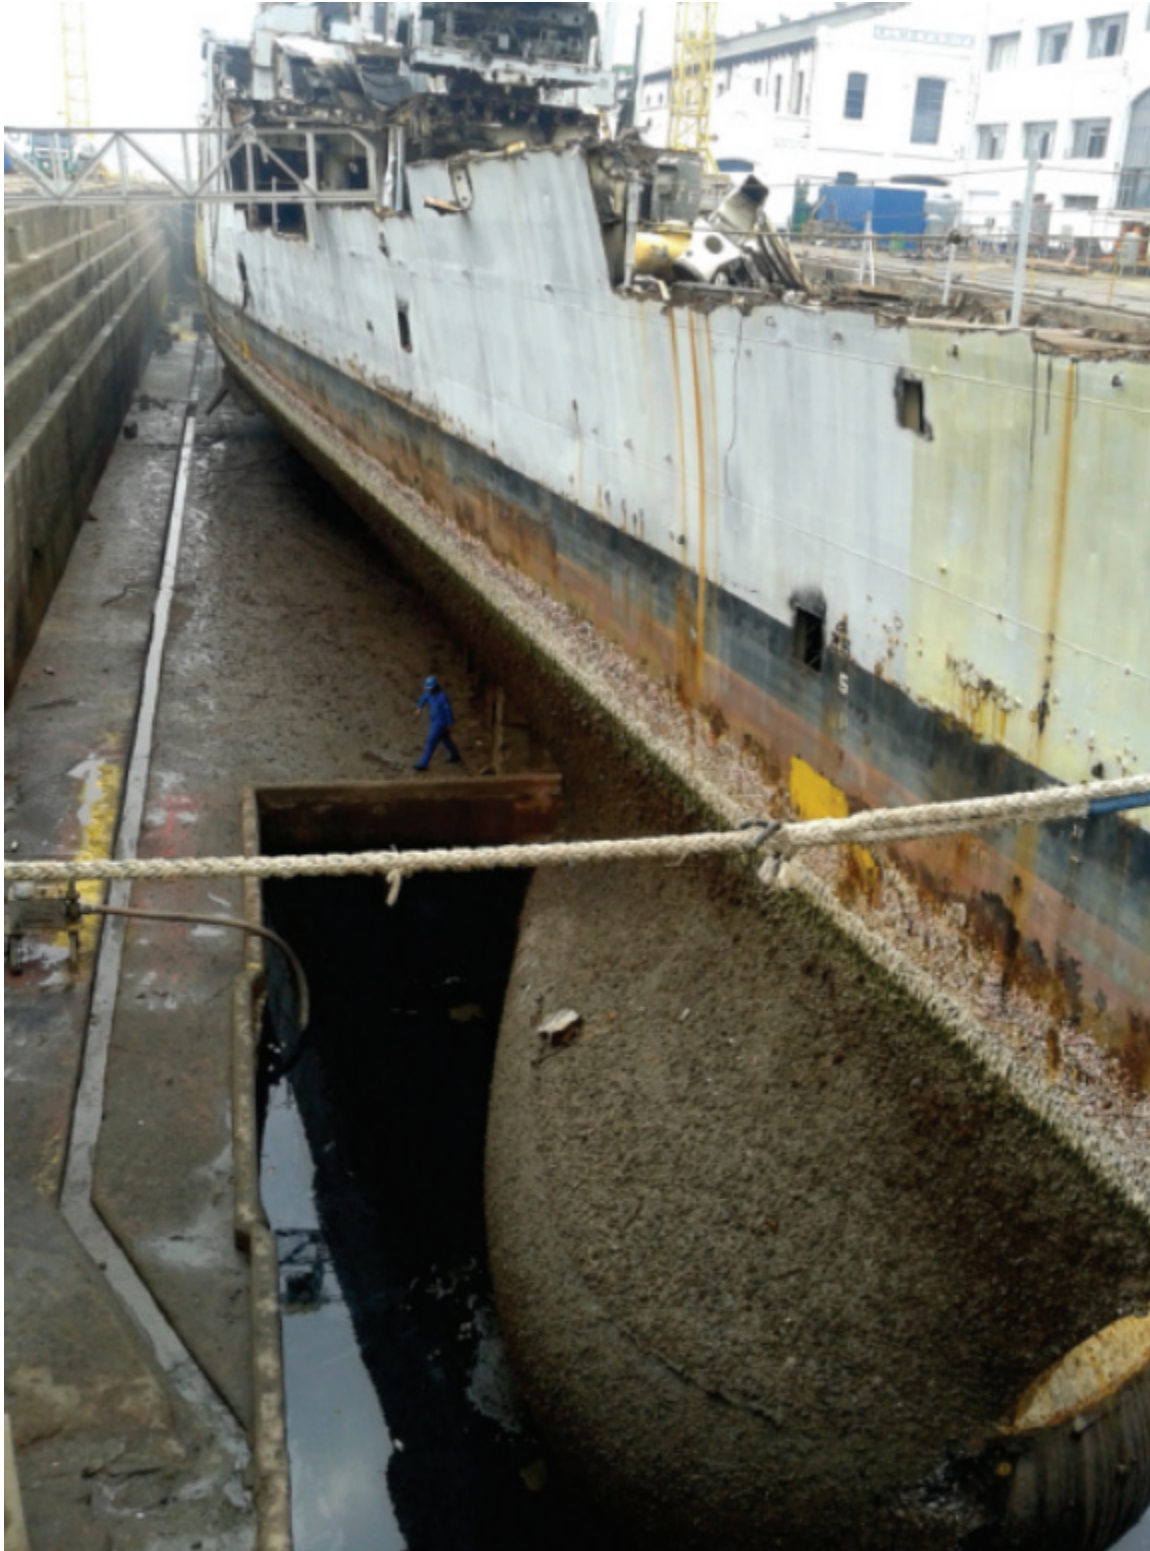
Photo 5: Dome housed in the moat, that is destined to the propellers of the Frigates Class Niterói

The second difficulty would be the need for the dock hull over an arrangement of riding stables and "ramp" berths, because, because the dome would drain 3.04m below the keel, even using one of the moats existing in that dam to accommodate it ( photo 5), at the moment the bottom of the dome rested in the bottom of the pit, there would be a difference of 0.85m from its keel in relation to the horizontality of the baseline of the original Pará Class docking plan. of a new plan of dockage, specially prepared for the unprecedented situation.

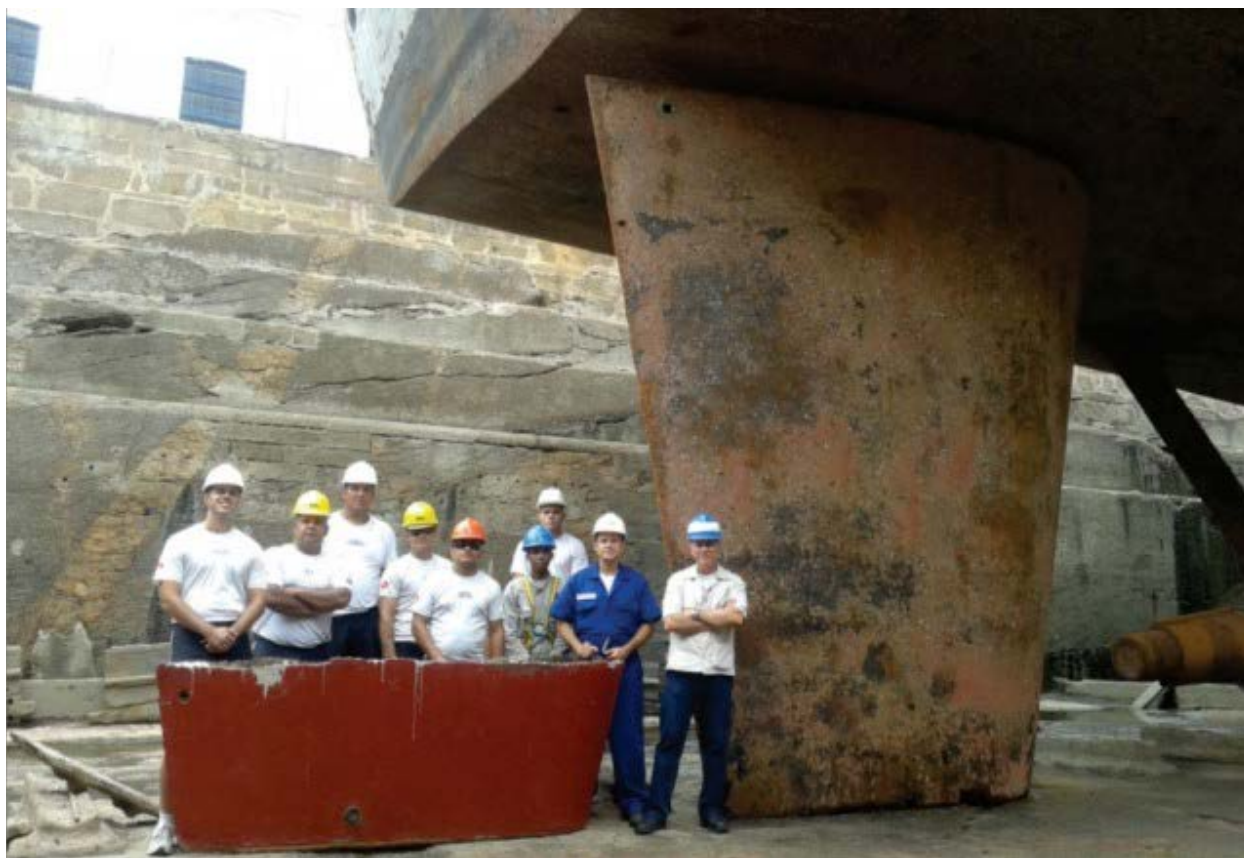
The last difficulty to be eliminated would be the reduction of the navigation draft to enable the entrance of the hull in the dike, even considering the prearms of sizígias. It occurs that, due to the fact that it presented, at the time, a marked stern trim, provoked by the expressive reduction of weight of its Alpha Section due to the partial dismantling of the bow, while it was moored, it was verified that, although its sonar was with a draft for entry into the dike, your rudder will not.

Photo 6 - Detail of the part of the rudder that was sectioned while the hull was still floating and also of the performance of the rudder as a "fortune column" supporting the stern

As a solution, it was decided to carry out the submerged cut of 0.80m from the door of its rudder, with the use of BACS divers. It should be emphasized that the accuracy of this service would be fundamental for the success of the docking operation, since, in addition to ensuring the passage of that appendix through the levee threshold, it would enable the use of the rudder itself as a "fortune" column to support all the section Charlie, which would be in balance, after the sewer of the dam (photo 6).

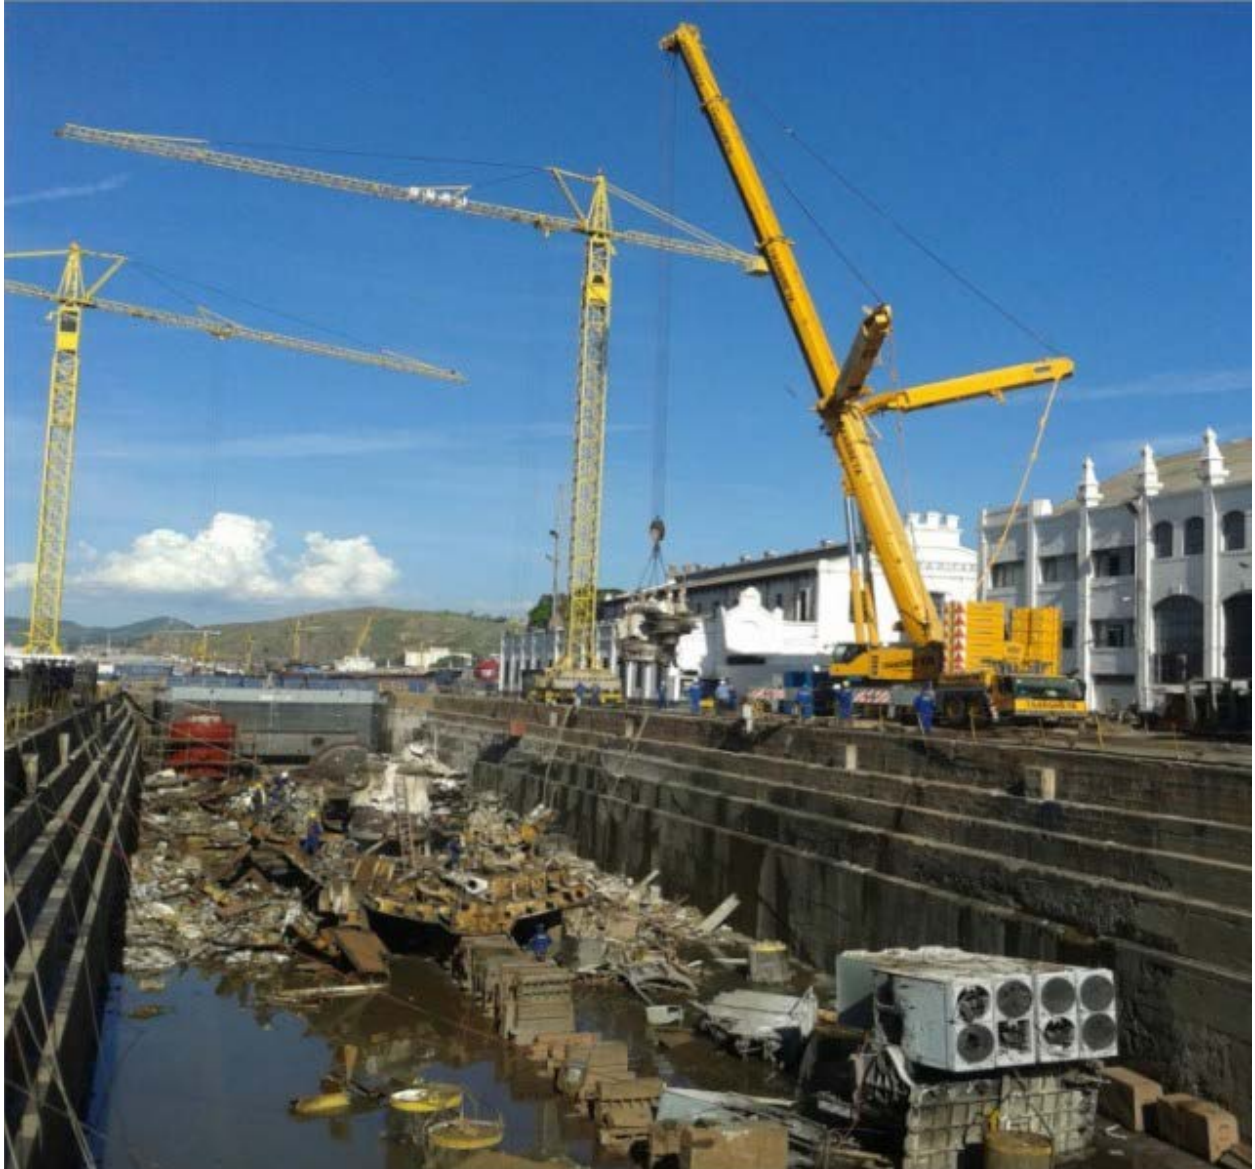
Photo 7 - Large capacity (up to 440t) contracted crane removing one of the boilers

- creation of the second shift of overtime by employees of the companies involved - including holidays and weekends;
- contracting of cranes with great capacity to remove large equipment and sections of the hull with larger weights and volumes (photo 7);
- requesting CavMec (mechanical horsepower) support from CFN Logistic Battalion to perform intra-Base displacements of large equipment and hull blocks (photo 8) to be dismantled later outside of the dam to shorten the critical path for its release (photo 9).

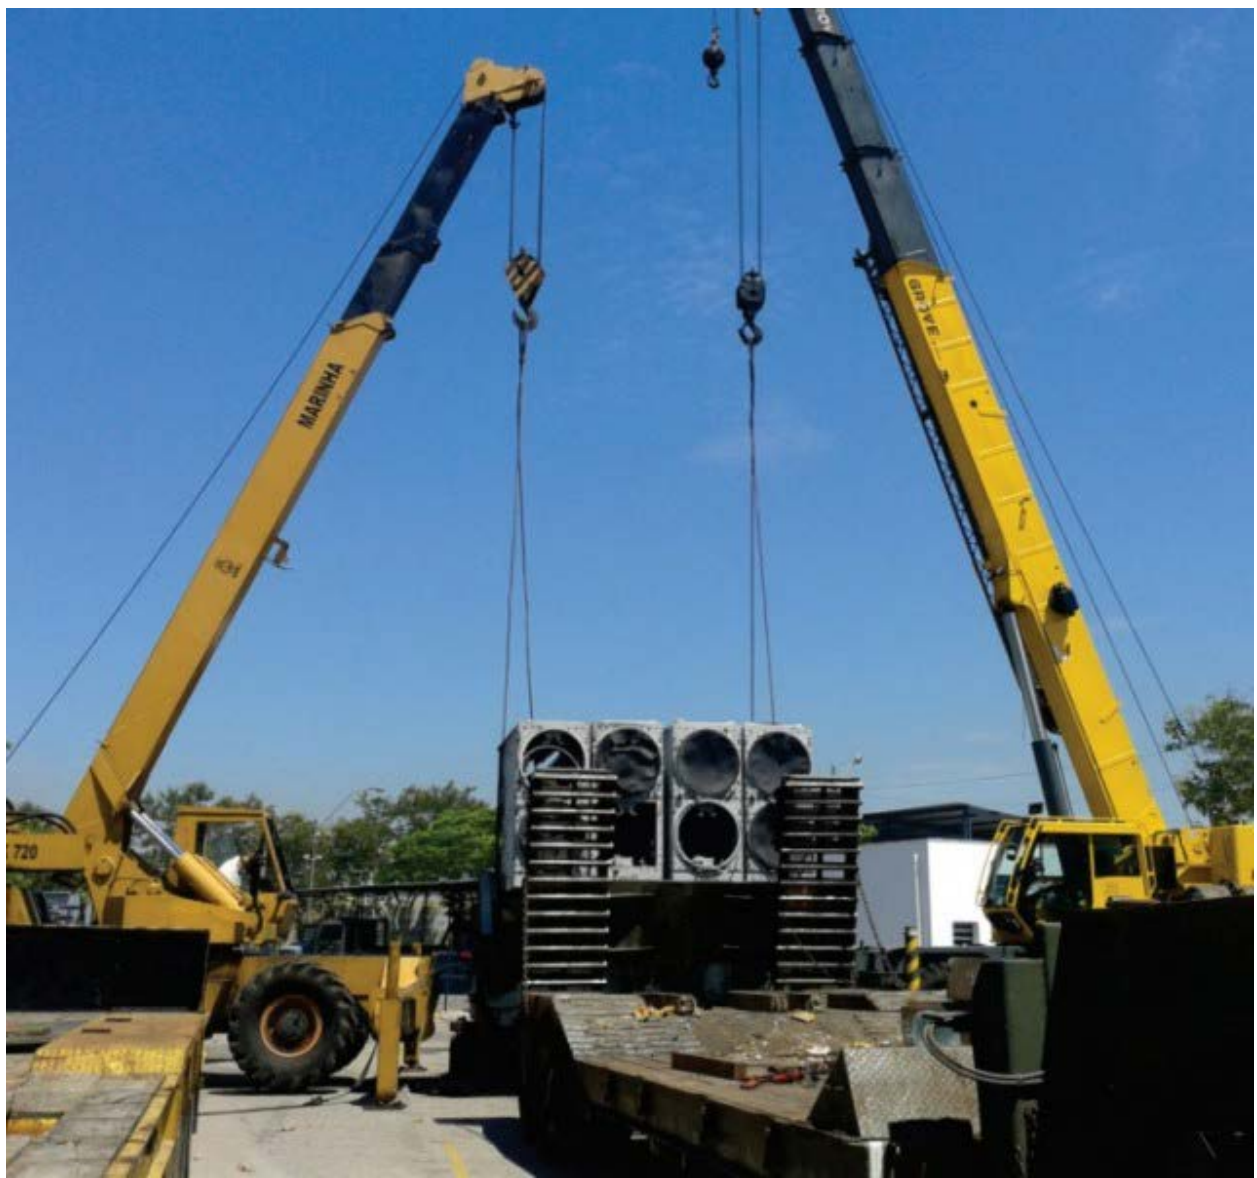
Photo 8 - Joint operation of two cranes on wheels of the BNRJ to remove the missile launcher (20t) ASROC from above the CavMec of the CFN

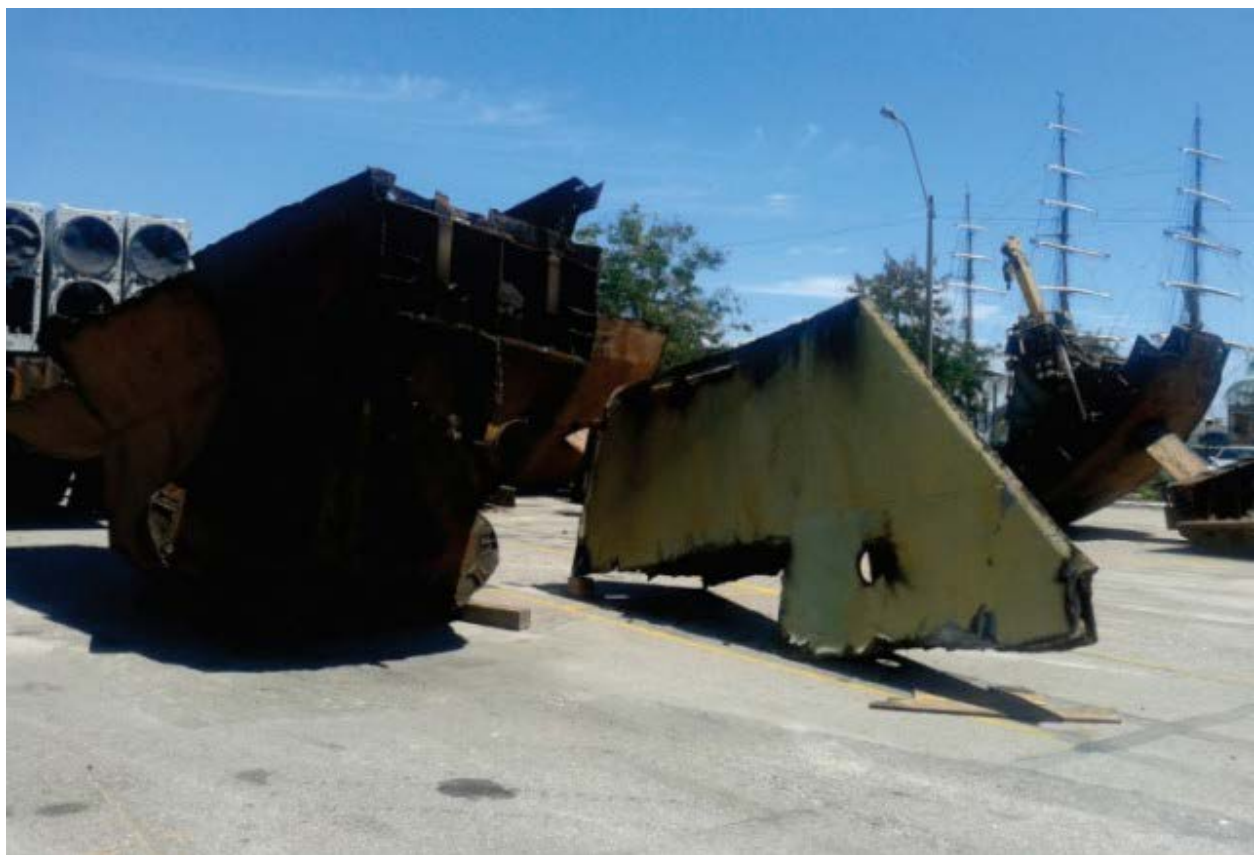
Photo 9 - Large blocks and equipment removed from the ex-D30 and displaced by CFM's CavMec, so that they could later be dismantled outside the dike
